## AVIATION INVESTIGATION REPORT

A04P0110

### LOSS OF CONTROL AND PARACHUTE SYSTEM DESCENT

CIRRUS DESIGN SR 20 C-GEMC  
MOUNT O'LEARY, BRITISH COLUMBIA

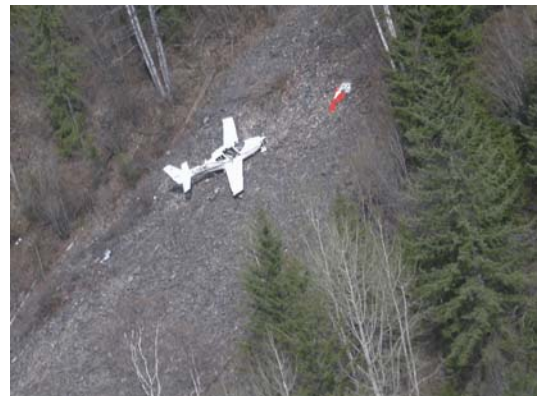
At approximately 2111, the aircraft/parachute landed on a steep mountainside on the southern slope of Mount O'Leary, British Columbia at the 2300-foot level. The aircraft sustained substantial damage, but there were no injuries. A search and rescue operation was initiated. The four occupants were found and rescued early the following morning and returned to Kelowna by military helicopter.

**Photo 1.** Accident site

Damage to the aircraft was mainly to its underside, and the nosewheel leg was broken. The engine crankshaft was damaged when a propeller tip contacted the ground. The right door was torn off during the CAPS deployment and was not found.

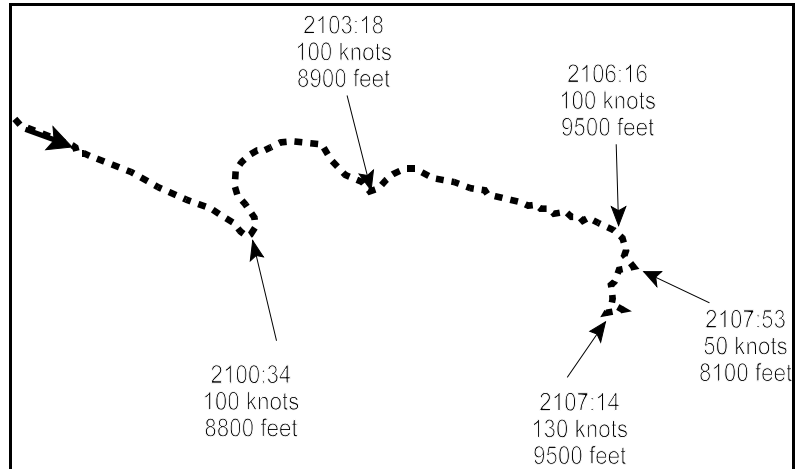
Radar data show that the aircraft was first detected at 2043:56 Pacific daylight time<sup>1</sup> at a position 13 nautical miles (nm) southeast of Kelowna Airport, on an east-southeast heading, climbing through 5700 feet, with a ground speed of 100 knots. The aircraft climbed steadily on that heading until 2100:34 when, at an altitude of 8800 feet and a ground speed of 100 knots, it made a fairly abrupt turn to the left reaching a heading of 325° True (T) before correcting back to the east-southeast heading.

Figure 1. Radar track of C-GEMC

At 2103:18 the aircraft made another left turn, reaching a heading of 052° T before again correcting to the east-southeast heading. At 2106:16, the aircraft reached 9500 feet and 25 seconds later began a turn to the south. At 2107:14 the event began. The last radar return was at 2107:53 as the aircraft descended through 8100 feet.
